COUNTRY	USSR (Arctic)	REPORT	
SUBJECT	1. Soviet Naval Vessels Sighted in the Arctic 2. Port of Arkhangelsk	DATE DISTR.	3 June 1955
DATE OF INFO.		NO. OF PAGES	11
PLACE ACQUIRED		REQUIREMENT	
DATE ACQUIRED		REFERENCES

COUNTRY	USSR (Arctic)	REPORT	
SUBJECT	1. Soviet Naval Vessels Sighted in the Arctic. 2. Port of Arkhangelsk.	DATE DISTR.	13 May 1955
DATE OF INFO.		NO. OF PAGES	11
PLACE ACQUIRED		REQUIREMENT	
		REFERENCES

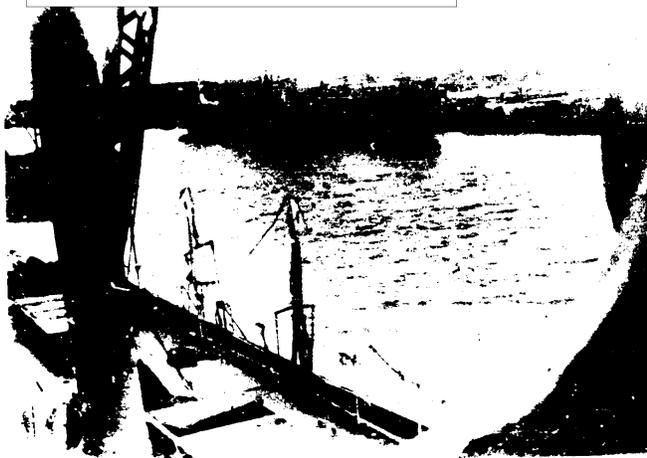
17N USSR N. EUROPEAN RSFSR ARKHANGEL OBLAST SOLOMBALA  
64 35 N 40 31 E FINNISH SHIP. LOADING LUMBER AT SAW-  
MILL. [REDACTED] [REDACTED]

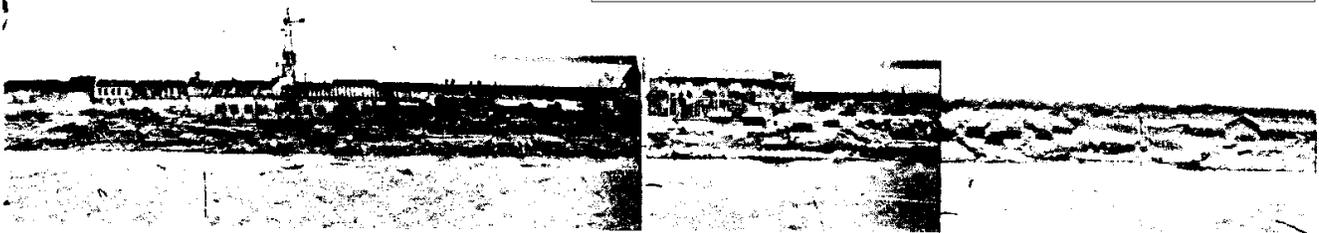
17N USSR N. EUROPEAN RSFSR ARKHANGEL OBLAST ARKHANGEL  
54 34 N 40 32 E SHIPYARD ON CHANNEL NORTH OF PORT EKONOMIYA.

14. [REDACTED] 25X1
15. On the way to the berth, [REDACTED] the left side of the channel a shipyard (2 on chart 1) for the construction of barges and small tugboats, some of which were on the building ways. (See photograph 2,) A large number of tugboats were also in the channel, towing lighters with railroad freight cars aboard. 25X1
